00V-403 (a)

On November 21, 2000, Honda Motor Co., Ltd. (HMC) determined that a safety-related problem exists due to potential for a clutch failure in all 2000 model year and certain 2001 year Honda CBR929RR motorcycles. The following information is submitted pursuant to the requirements of 49 CFR 573.5.

2000-2001 Honda CBR929RR Clutch Recall

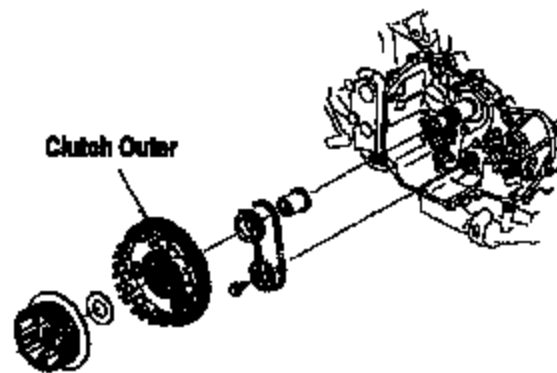
**CLUTCH OUTER ILLUSTRATIONS**

When the clutch lever is released to the friction point, but the lever is not completely released to fully engage the clutch (slipping the clutch), strong clutch disk judder may occur at the higher engine rpm used for rapid or racing-type starts. The stress created by this strong judder can cause the clutch outer to fail. (See attached drawing and photograph.) Typical failure results in several large sections cracking and eventually separating from the clutch outer. These separated pieces of the clutch outer could potentially, depending on their unpredictable migration paths, cause the rear wheel to lock, the engine to stop or engine oil leakage from the crankcase.

The owners of all affected vehicles will be notified by mail and asked to take their motorcycle to an authorized Honda dealer. The dealer will install a clutch kit that includes a redesigned clutch outer, judder spring and other parts intended to reduce stress on the clutch, free of charge. The dealers will also be instructed to install a new, redesigned clutch lifter lever.

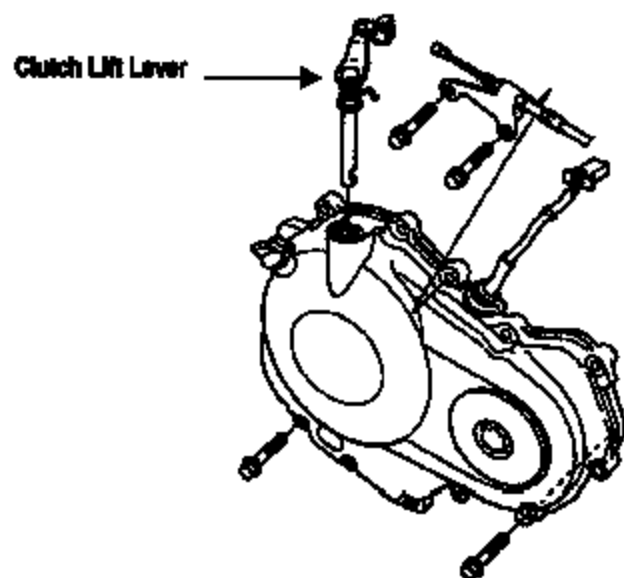
## CLUTCH LIFT LEVER ILLUSTRATIONS

Additionally, the clutch lift lever shaft does not have sufficient strength and may fail when the clutch is applied. (See attached drawing.) Stress concentration at the machined end of the shaft can cause the shaft to crack or break. As a result, the rider would not be able to disengage the clutch.
